# Cochlear™ Osia®

## Magnetic Resonance Imaging (MRI) Guidelines

This guide applies to the Cochlear™ Osia® OSI200 Implant and OSI300 Implant. It is intended for:

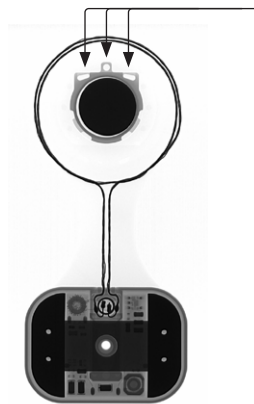
*Fig.4: OSI300 Implant*

*Three holes adjacent to magnet*

Cochlear Osia implants are made of metal and are implanted under the skin behind the ear. Use the *Fig.1–Fig.4* to assist with identifying Cochlear Osia implants when using an X-ray.

Lateral X-ray at 70 kV/ 3 mAs provides sufficient contrast to identify the implant. A modified Stenver's view is not recommended for implant identification as implants may appear oblique. Imaging should include an unobstructed view of antenna coils and implant bodies. Bilateral recipients may have different implant models on either side of the head. A lateral skull X-ray with a 15 degree cranial tube angle will offset the implants in the image, enabling identifying features to be distinguished.
