# Cochlear™ Osia®

## Magnetic Resonance Imaging (MRI) Guidelines

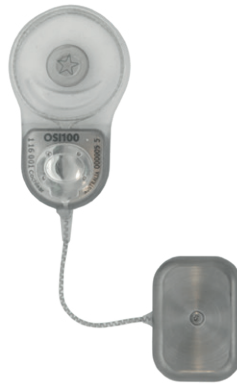
*Fig.1: Approximate location of the OSI100 Implant*

Cochlear Osia implants are made of metal and implanted under the skin behind the ear. Use the *Fig.1-Fig.4* on *page 10* to *11* to assist with identifying Cochlear Osia implants when using an X-ray.

Lateral X-ray at 70 kV/ 3 mAs provides sufficient contrast to identify the implant.

Imaging should include an unobstructed view of antenna coils and implant bodies.
