Cochlear™ Osia®

Magnetic Resonance Imaging (MRI) Guidelines

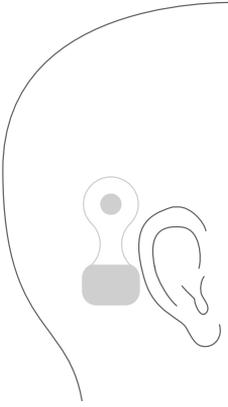
Fig.1: Approximate location of the OSI200 Implant

Cochlear Osia implants are made of metal and are implanted under the skin behind the ear. Using an X-ray, the implant can be identified by its shape and the shape of the actuator unit. Use the *Fig. 1-Fig. 4* to assist with identifying Cochlear Osia implants when using an X-ray.

Lateral X-ray at 70 kV/ 3 mAs provides sufficient contrast to identify the implant. A modified Stenver's view is not recommended for implant identification as implants may appear oblique. Imaging should include an unobstructed view of antenna coils and implant bodies. Bilateral recipients may have different implant models on either side of the head. A lateral skull X-ray with a 15 degree cranial tube angle will offset the implants in the image, enabling identifying features to be distinguished.

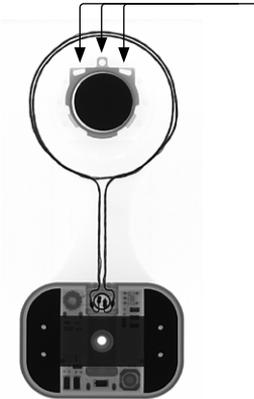
Fig.4: OSI300 Implant

OSI300 Implants can be distinguished from OSI200 Implants by the three holes adjacent to the magnet. See **Fig.2** and **Fig.4**.

Three holes adjacent to magnet

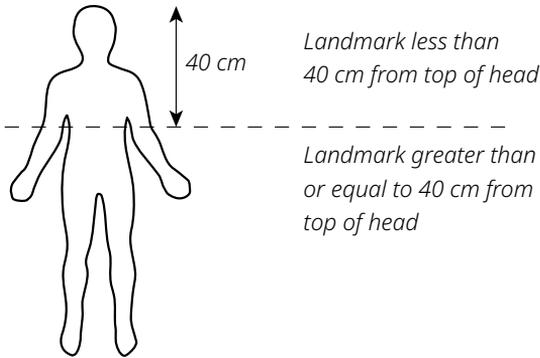
Fig.5: Landmark locations

- Transmit/receive head coils and whole body coils may be safely used within the recommended SAR limits. Refer to the MRI safety information and recommended SAR limit tables in the following pages.
- Local cylindrical transmit/receive coils may be safely used, without SAR restriction, provided that the distance between the entire implant and the end of the local RF coil is at least equal to the radius of the local RF coil.
- It is safe to use local cylindrical RF receive only coils with implants during MRI scanning, provided SAR limits for the transmit coil have not been exceeded.

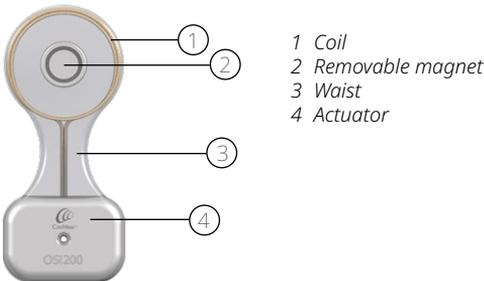
Fig.7: OSI200 Implant (P1170466)

- Touch – gently feel around the implant site to locate the position of the implant coil. The implant is comprised of the round implant coil, the waist and the actuator **“Fig.7: OSI200 Implant (P1170466)”**.

The implant magnet will be at the centre of the implant coil. For further explanation of the prevailing implant see **“X-ray information for Cochlear Osia implants”** section.

Skin side

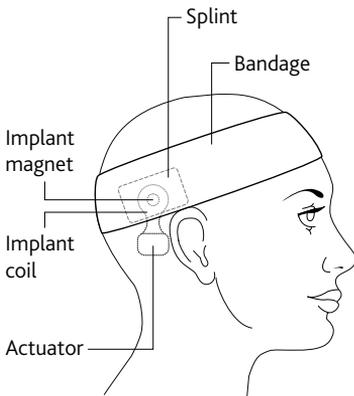
1. Use a splint from the MRI Kit and centre it over the implant magnet site (as marked) against the skin. Ensure the splint is held in place over the implant magnet. You may need the assistance of another person to hold the splint in place while you bandage. Otherwise, use the supplied tape to maintain the splint position prior to bandaging.
2. Use the elasticised compression bandage from the MRI Kit and ensure the centre line of the bandage is over the implant magnet site and the splint is fully covered. See Figure 5.

Fig.9: Fitting the MRI Kit splint and compression bandage. Position the splint over the implant magnet site and then apply the bandage over the centre of the splint and the centre of the implant magnet site.

3. Use a minimum of two bandage layers at full stretch (no elasticity remaining in the bandage). When the bandage is at its maximum tightness, the small rectangular tension markers will stretch to become square in shape. See "**Fig.10: Comparison of compression bandage tightness**" on page 23.
4. Use the surgical tape from the MRI Kit to secure the bandage by wrapping two surgical tape layers around the head, over the bandage center line. Ensure the tape ends overlap.
5. Conduct the MRI scan.
