Cochlear[™] Osia[®] OSI200 Implant

Magnetic Resonance Imaging (MRI) Guidelines

This guide provides information about the safe application of an MR scan on Cochlear Osia OSI200 Implant recipients.

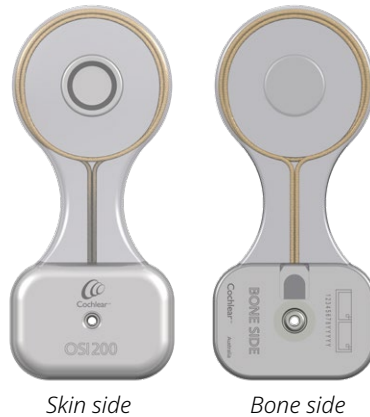
Cochlear Osia OSI200 Implants are made of metal and implanted under the skin behind the ear. Using an X-ray, the implant can be identified by its shape and the shape of the actuator unit.

Fig.2: OSI200 Implant (P1170466)

Use the **Fig.1** and the **Fig.2** to assist with identifying Cochlear Osia OSI200 Implants when using an X-ray.

Lateral X-ray at 70 kV/ 3 mAs provides sufficient contrast to identify the implant.

A modified Stenver's view is not recommended for implant identification as implants may appear oblique.

Imaging should include an unobstructed view of antenna coils and implant bodies.

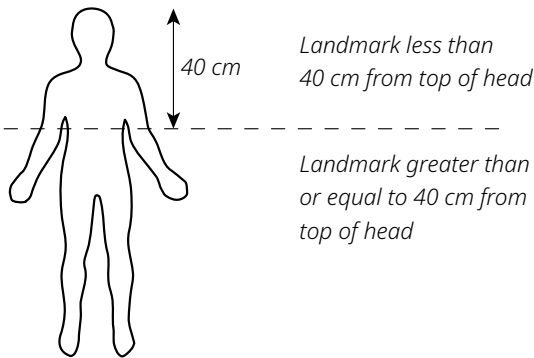
Fig.3: Landmark locations

- Transmit/receive head coils and whole body coils may be safely used within the recommended SAR limits. Refer to the MRI safety information and recommended SAR limit tables in the following pages.
- Local cylindrical transmit/receive coils may be safely used, without SAR restriction, provided that the distance between the entire implant and the end of the local RF coil is at least equal to the radius of the local RF coil.
- It is safe to use local cylindrical RF receive only coils with implants during MRI scanning, provided SAR limits for the transmit coil have not been exceeded.
- Local planar (flat linearly polarized) receive only RF coils should be kept more than 10 cm away from the implant.
