# **Cochlear<sup>™</sup> Osia<sup>®</sup>**

## **Magnetic Resonance Imaging (MRI) Guidelines**

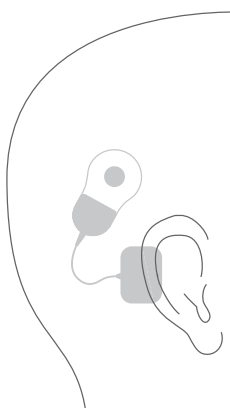
*Fig.1: Approximate location of the OSI100 Implant*

Cochlear Osia implants are made of metal and implanted under the skin behind the ear. Use the ***Fig.1-Fig.4*** on ***page 11*** to ***12*** to assist with identifying Cochlear Osia implants when using an X-ray.

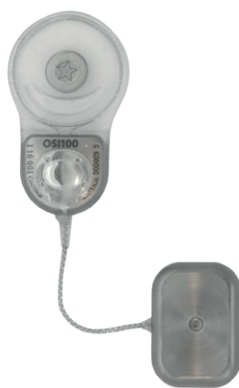
*Skin side*

*Fig.2: OSI100 Implant*

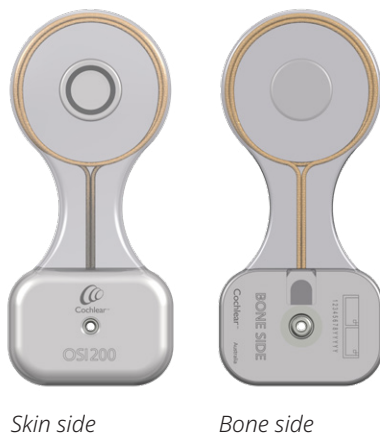
*Fig.4: OSI200 Implant*
